MINNOW LAKE SEDIMENT QUALITY ASSESSMENT

Jan Linqvist
Senior Water Resources Scientist
N.A.R. Environmental Consultants Inc.

Minnow Lake Restoration Committee

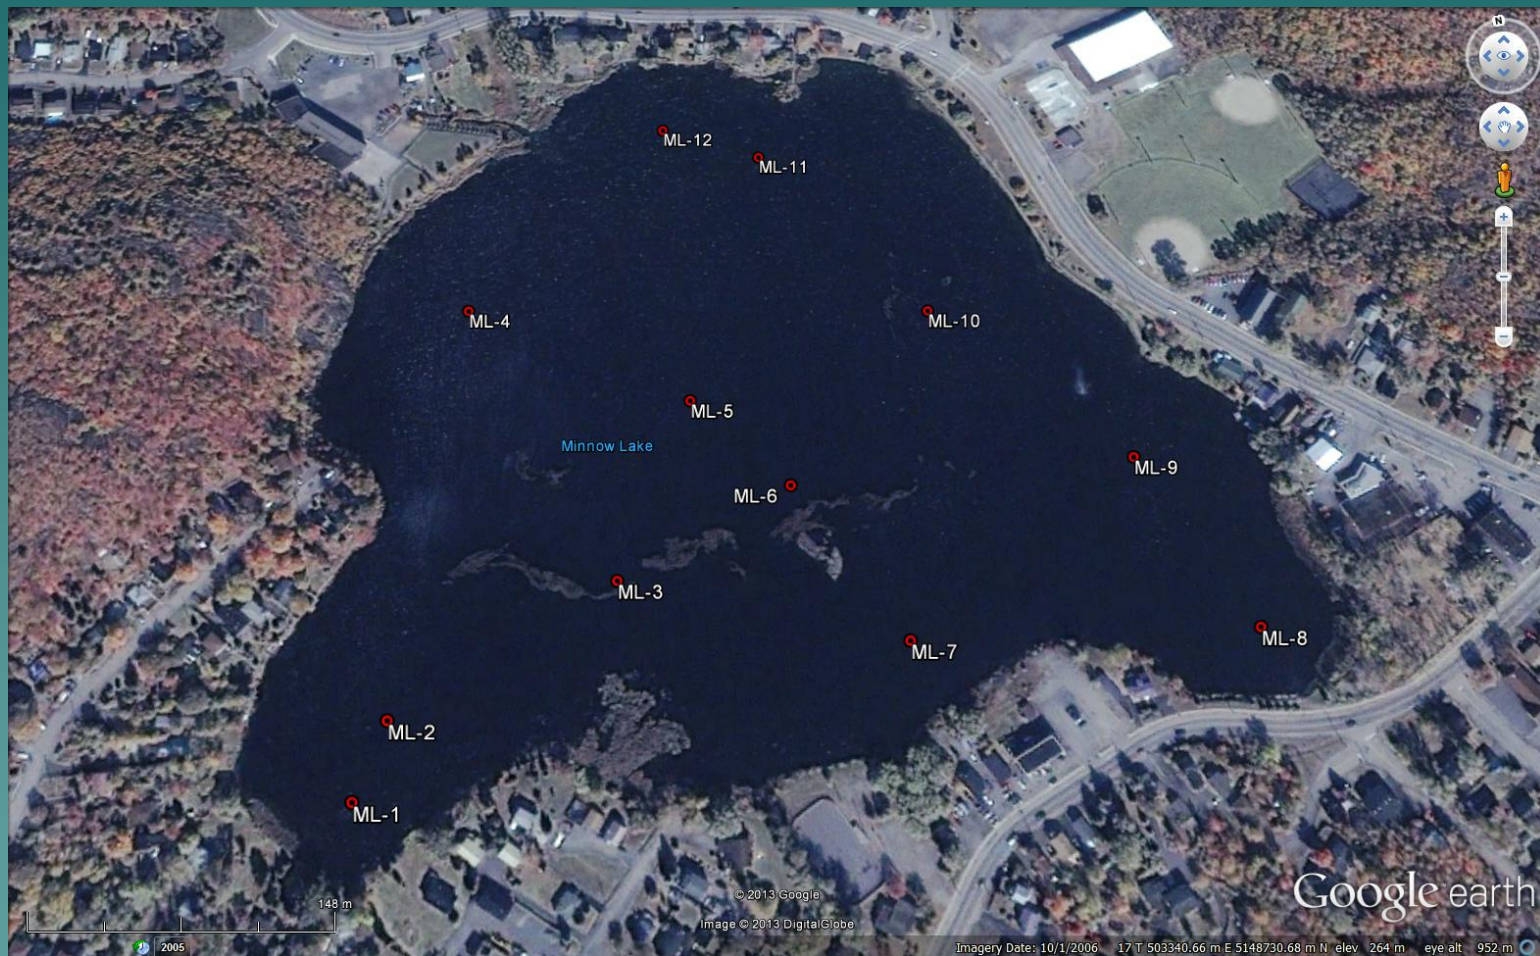
Sediment Sampling Station Locations 1994 and 2012

- ◆ Sampling conducted at same stations in 1994 and 2012
 - ◆ Collected using an Ekman dredge grab sampler
 - ◆ Top 2.5 cm of sediment removed
 - ◆ Submitted for chemical analyses to Testmark Laboratories
 - ◆ Stations geo-referenced, samples photographed and physical description recorded

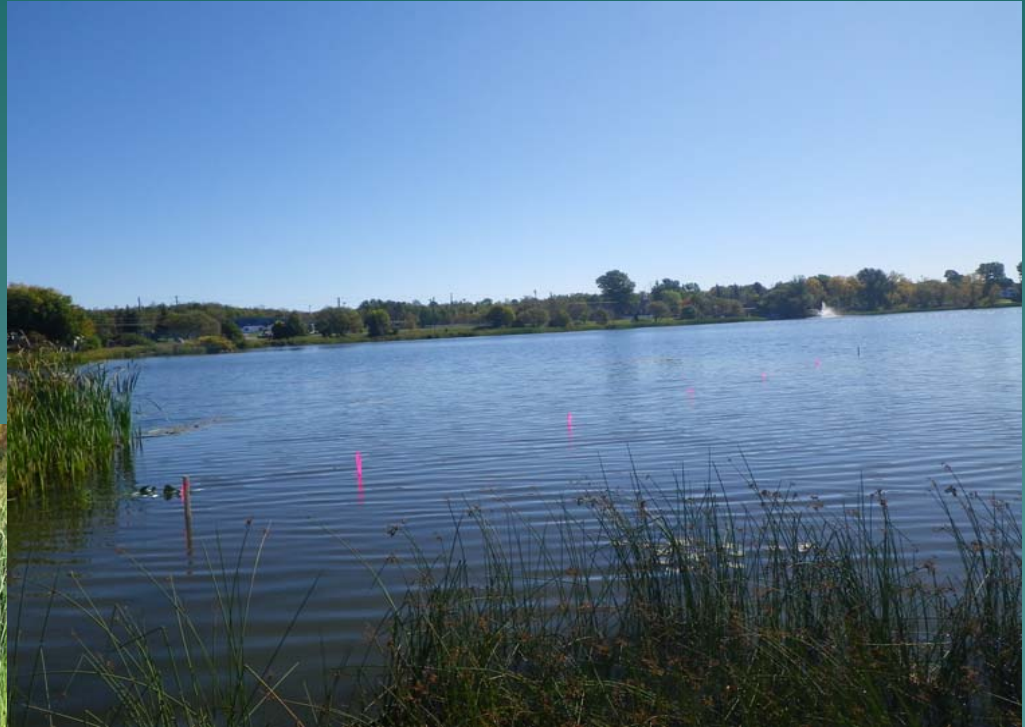
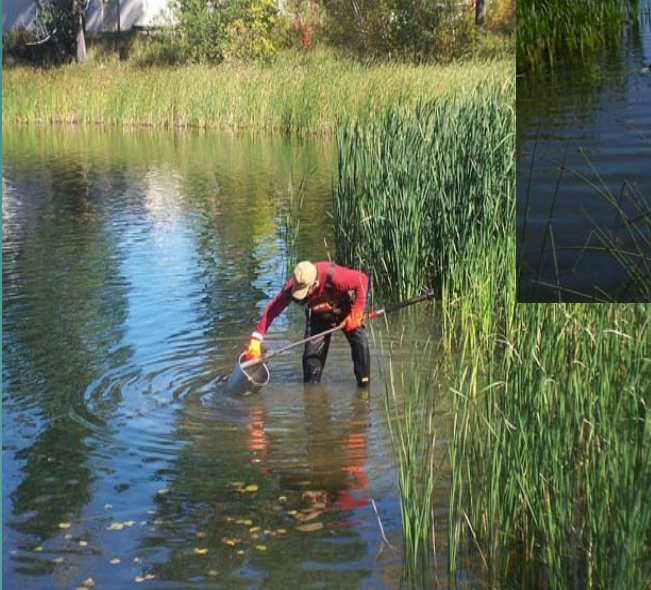
Sediment Mapping

- ◆ Increase in sediment accumulations around storm water outlets noted in recent years – result of development within watershed
 - ◆ Mapping of depth and extent around outlets mapped in 2013
 - ◆ Results pending
-
